## **Appendix 1-A**

### **A-1 AUTO PARTS WILMINGTON, DELAWARE**

**SIRB ID: DE-1172**

PCB Mass Loading  
A-1 Auto Parts  
SIRB ID: DE-1172  
Wilmington, Delaware

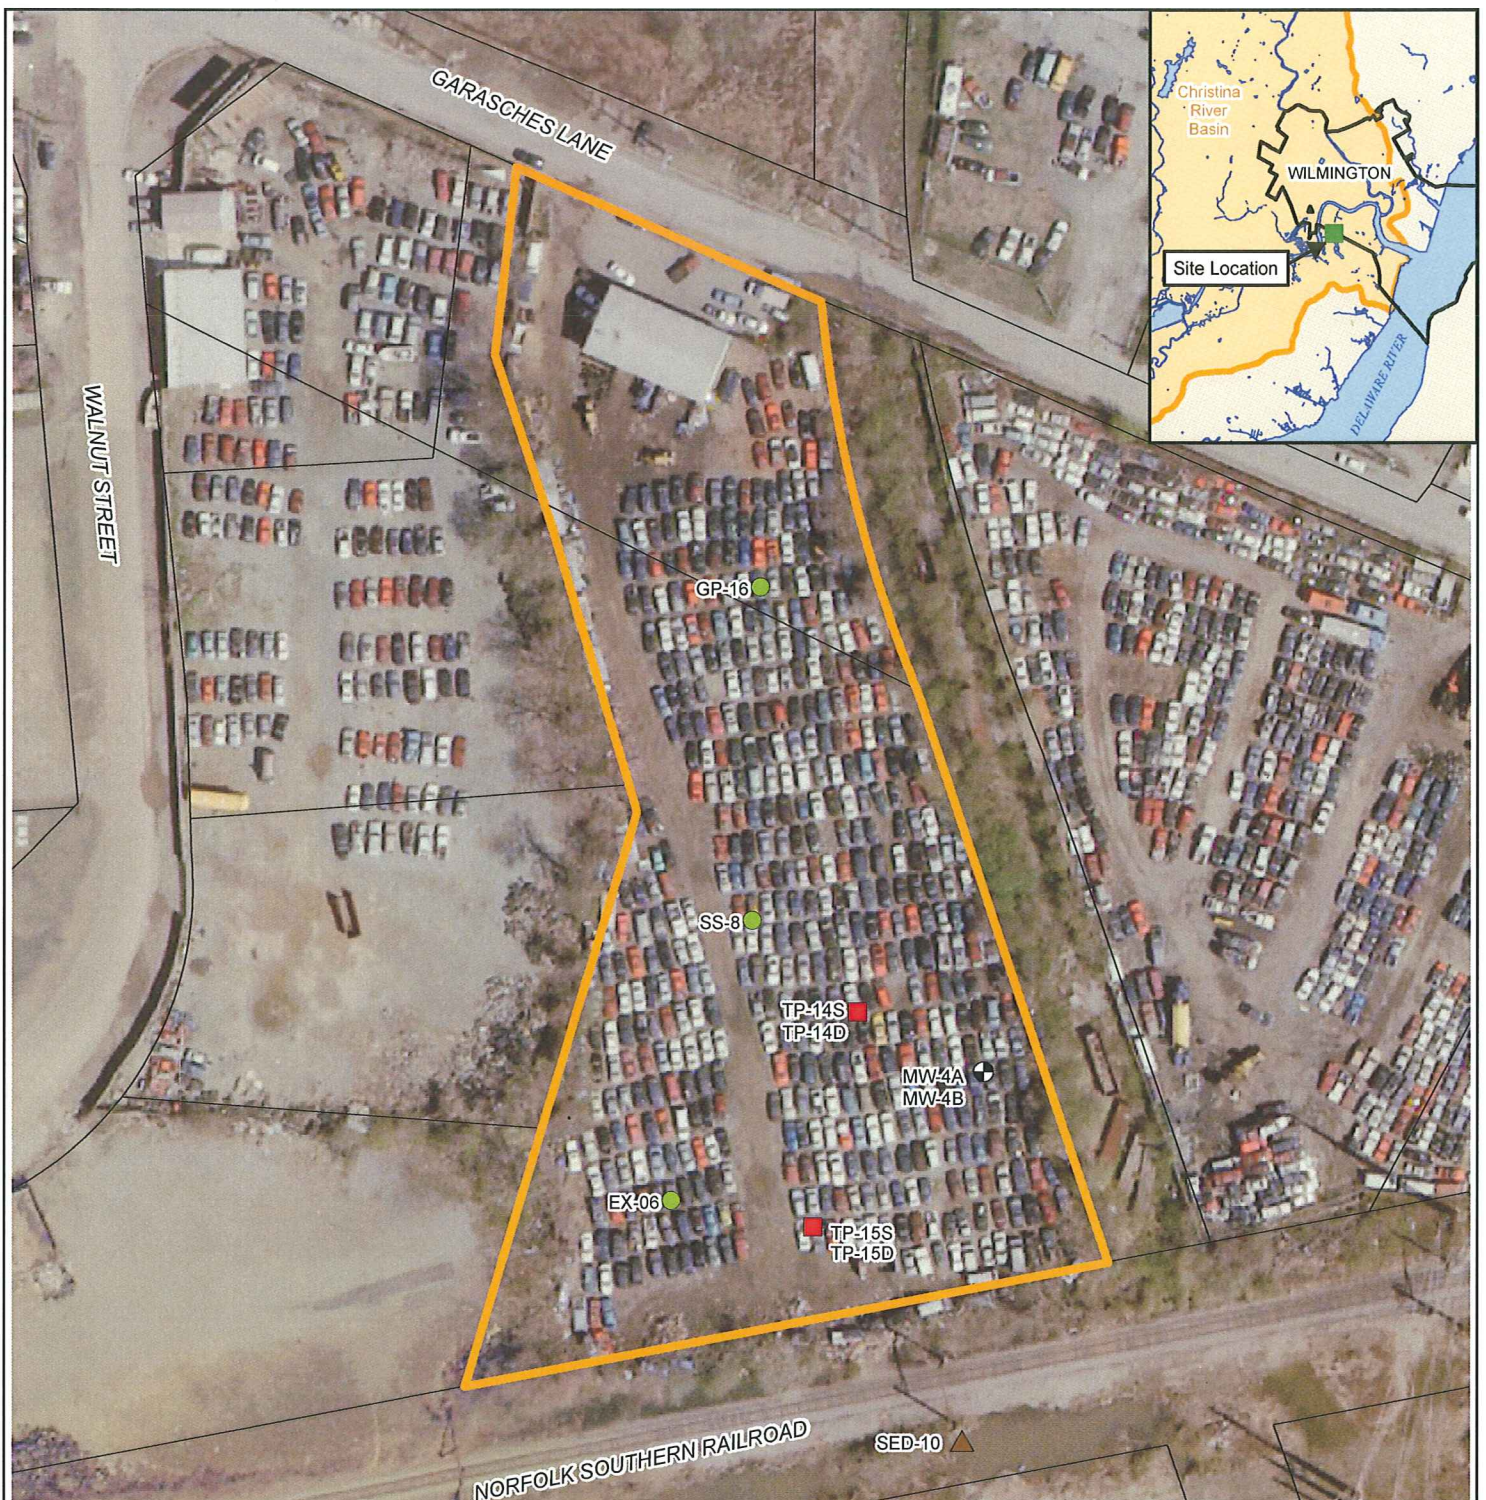
By	Date	Scale:	File Name:
Drawn	SMD	8/14/08	1:1200	a-1 aerial.mxd
Checked	JPR	8/14/08	Fig. No.	
Project #	0985.26.51		Figure 1

Historic Sample Locations and  
Aerial Photograph (2007)  
A-1 Auto Parts  
Wilmington, Delaware
